Removing the Risk of Concentrated Salt Solutions to Precision Dispense Pumps

By: William Easterbrook, VP of Engineering for BioChem Fluidics

Published On: March 9, 2017

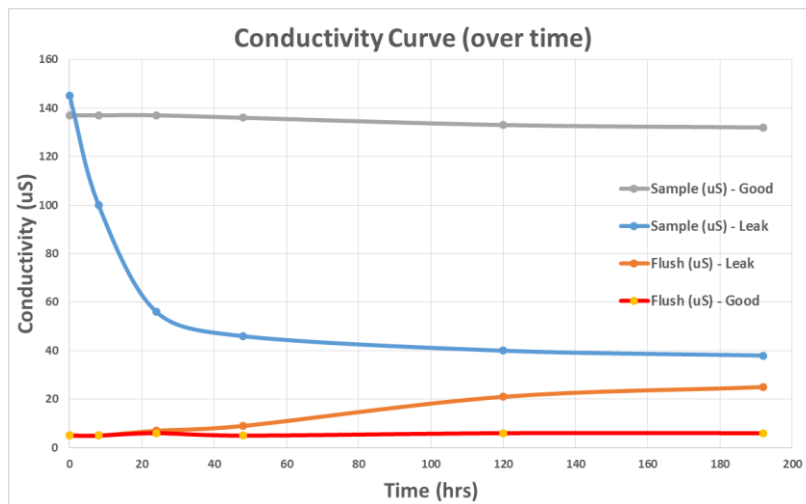
Figure 1 Concentration changes in sample over time

- The blue dye was seen to transfer from the saline solution to the distilled water solution within a few hours, resulting in a light blue coloration. A significant change in coloration was seen after two days.
- Conductivity of the saline solution and distilled water remained fairly constant over the 8 days in the pump with no leak in the primary seal; while the conductivity of the saline solution and distilled water moved using the pump with a verified leak in its primary seal starting within the first 24 hours and generally reaching equilibrium within 72 hours, as predicted in the qualitative method described above. Note that the rate and magnitude

of change in the conductivity will be affected by severity of the seal/piston degradation, as well as the pressure differentials in the specific application. It would also be expected that the rate of fluid transfer would be accelerated in the presence of surfactants. See Figure 1 below for an analysis of the resulting data.

The data collected, both qualitative and quantitative, supports the hypotheses above that fluid will transfer across the primary seal of a Flushed Seal Pump, at rates dependent on the application's differential pressures, and the end user will not likely notice this phenomenon. Since Piston Pumps are not equipped with internal conductivity sensors and there is no change in the dispensed volume of fluid, there is no direct means of determining if this is occurring. All of these failures lead to either poor test results or increased downtime and maintenance, while costing more for the pump itself and the flushed circuit.

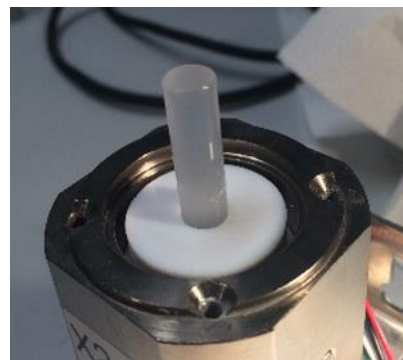
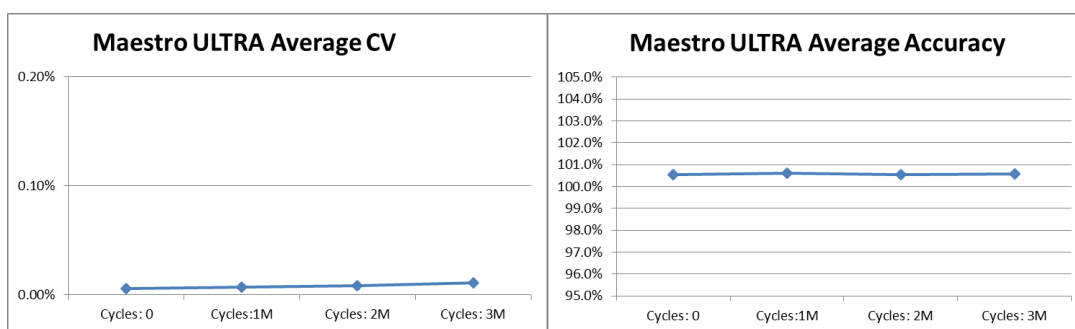
The Maestro ULTRA provides an elegant and robust solution to this industry-wide problem by creating hydrophobic, low surface energy pistons. This combination decreases wettability and prevents materials from adhering to its surface, thereby resulting in “non-stick” pistons. As illustrated in the photo to the right, following 3 million full aspirate/dispense cycles of use, there is no evidence of seal abrasion and no presence of salt crystals. The hydrophobicity and low surface energy of the Patent Pending piston in the Maestro ULTRA eliminates seal degradation, allowing long service life of the piston pump in concentrated salt solutions. The Maestro ULTRA has the same expected high performance as standard Maestro products with Cv of less than 0.04%, and accuracy within 0.7% dispense volume, from 10% to 100% of total dispense volume, as seen below.
